WOLLATON PARK GOLF CLUB

Advisory Report on the new 5th Tee and performance of the playing surfaces on the 5th – 7th holes

Report Date: 9th March 2021
Consultant: Michael Boyes

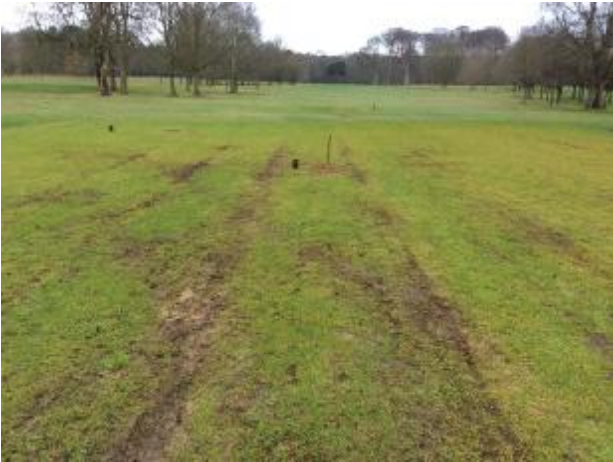
- The surface of the relatively new 5th tee has been impacted significantly under inclement conditions in recent months due to restricted infiltration and percolation through the constructed soil profile, resulting in standing water, a softening of the surface and a deterioration in turf grass health and density.

Figure 1: The relatively newly constructed 5th tee has deteriorated significantly in recent months under inclement conditions and is very soft underfoot.

- No course of redress is appropriate with the contractor who acted on the Club's instruction, therefore when ground conditions improve, an extensive programme of aeration and sand top-dressing has been agreed in conjunction with appropriately timed overseeding operations.

- Provision is also to be made for the retrospective installation of a primary plastic pipe drainage network at the earliest opportunity.

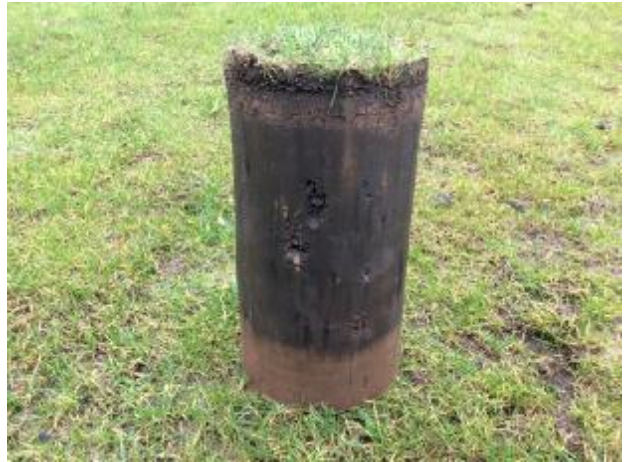
- The reconstruction works on the 5th Tee were carried out primarily by an external contractor (Lakeland) in accordance with the express instructions of the Club, utilising subsoil and rootzone materials stripped from the existing tees and stockpiled adjacent to the extended construction site.

Figure 2: The soil profile taken from the relatively dry front section of the 5th tee reveals the composition of materials used.

- As soon as weather and ground conditions are conducive, undertake solid pencil tine aeration (6mm – 8mm Ø tine) with the pedestrian Toro Pro Core 648, to a minimum of 100mm in the drier front and rear sections of the tee. Incorporate sand top-dressing.

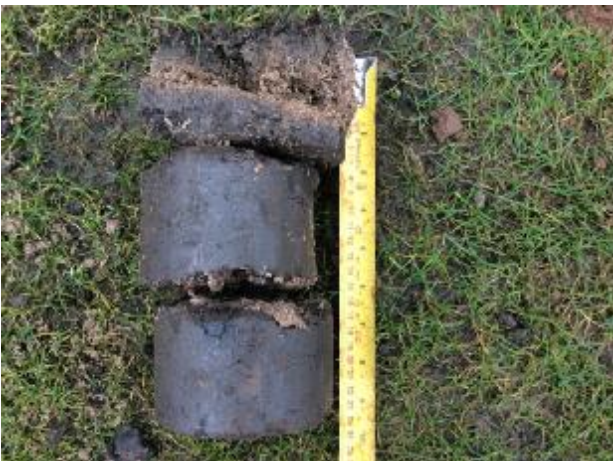
- Upon reinstatement, the recycled construction materials have been worked excessively in the establishment of desired surface levels, leading to compaction which is having an ongoing negative influence on drainage potential. The water retentive nature of the upper soil profile has stunted root growth and led to algal build-up, deterioration of turf health and a loss of grass cover in selected areas.

Figure 3: At the wetter, rear of 5th teeing platform the compaction of the constructed layers is evident which is restricting root development and water percolation.

- Carry out selective manual “drill N fill” operations on the most problematic central section of the 5th tee to remove existing constructed soil profile and replace with straight sand through to the drainage layer.

- Make provision for deep solid tine aeration (minimum 19mm Ø tine) to a depth of 300mm (zero heave) and follow with heavy sand top dressing to fill the resulting tine holes to the surface and provide connectivity with the underlying drainage medium.

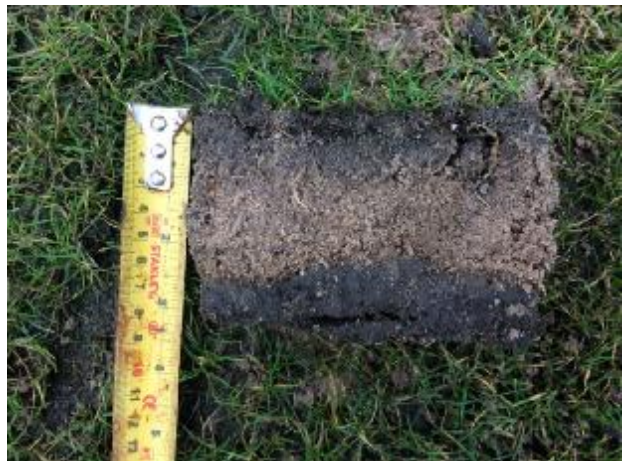
Figure 4: A shallow sand layer is apparent above the constructed profile and grass coverage is weak on the surface, with limited root penetration.

- Complement extensive deep solid tine aeration (i.e., Verti-Drain) prescribed above with a programme of regular/routine shallower solid tine aeration, at varying depths of penetration and using differing tine diameters, to break up compacted layers throughout the constructed profile. Follow with light dustings of sand top dressing at every available opportunity.

- Undertake Sarel rolling for shallow penetration on the surface and follow with frequent, light dustings of sand to firm and dry the surface and degrade thatch. Plan for overseeding operations when surface conditions are suitable and forecast weather is favourable for germination.

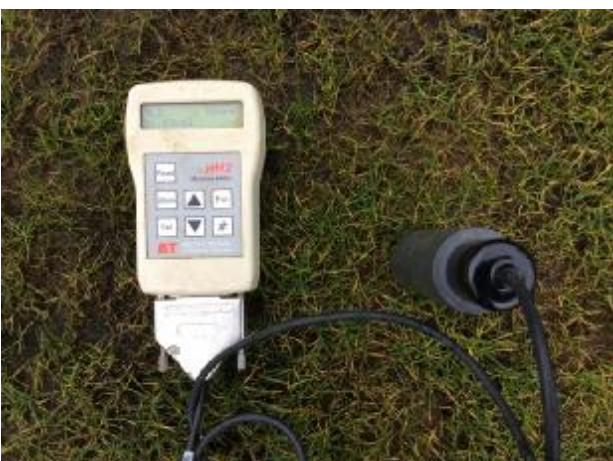
Figure 5: The playing surface is particularly water retentive due to poor infiltration/percolation, recording a value of 41% on the day.

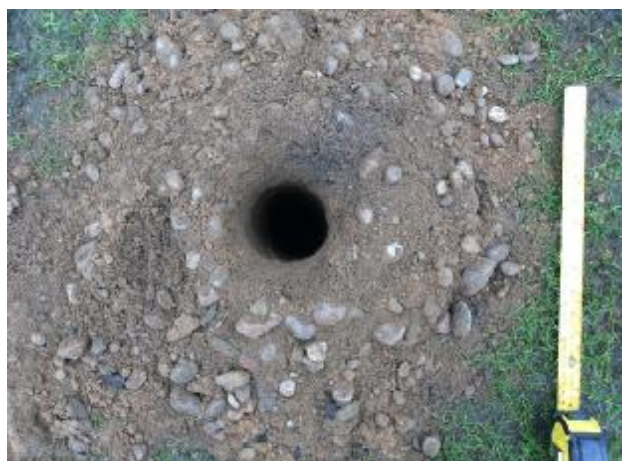
- It was suggested that the contractor did recommend the incorporation of primary plastic pipe drainage as part of the reconstruction, but this offer was declined by the Club.

Figure 6: A friable and free draining medium is employed at depth in the construction but the compaction of the materials above, and a lack of formal pipe-drainage, is rendering the surface unplayable.

- Upon substantial improvements in drainage capabilities and increased health and density of the grass sward on the tee, plan for installation of a primary perforated plastic pipe drainage network.

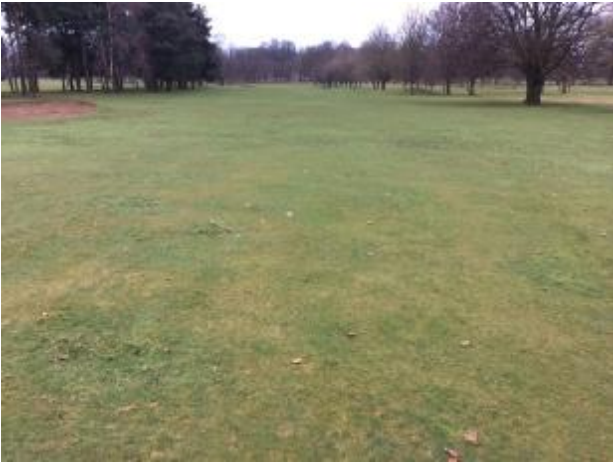
Figure 7: The front section of the 4th fairway displays a good proportion of the more desirable grass species and a very good playing surface due to the relatively free-draining nature of the sub-soil structure.

- Consider scarification operations across the denser turf areas (i.e., start of the 4th fairway) to remove excess build-up of organic matter for the incorporation of sand top dressing to develop an even stronger playing surface, dominated by the finer grasses.

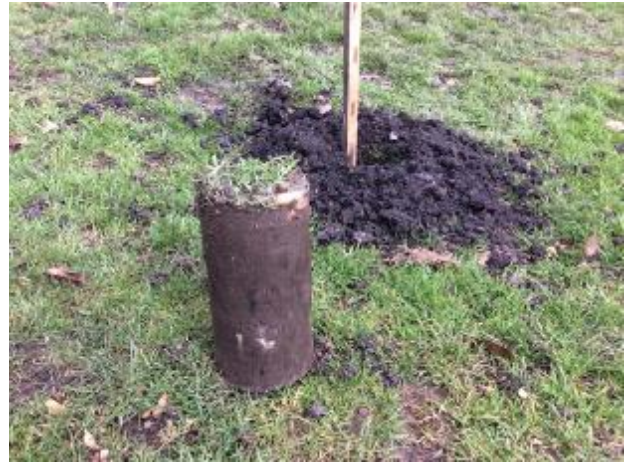
- The area of the golf course, which primarily encompasses the 5th – 7th holes, historically represents the wettest part of the site due to its low-lying nature. A central section which bisects the area contains a seam of less than desirable underlying materials which is impeding drainage and restricting root system development and extension. Subsequently, soils on the affected fairways are largely impermeable leading to standing water during wetter, winter months and are at risk of "baking-off" during periods of extended hot/dry weather. Neither is conducive to the promotion and sustainability of dense and healthy grass cover. It was reported that routine aeration practices in the impacted areas have been extremely limited in recent years.

Figure 8: In contrast, a depressed central section of the 5th fairway is notoriously problematic and reflected in weakened grass cover, due to a seam of less desirable material which bisects this part of the golf course.

- Corrective action is advised in the form of localised hollow coring operations for the removal of organic matter accumulation, the aeration of the soil profile, amelioration of sand top-dressing and overseeding. Regular deep solid tine aeration (i.e., Verti-Drain) is prescribed a minimum of twice per year through the entire area.

- Undertake localised hollow core aeration, using as large a diameter tine as available, to target the problematic seam of material on the 5th fairway. Allow the resultant cores to dry on the surface before pulverising them with scarifying units, metal drag mat the soil element back into the tine holes and disperse the remaining organic material with blowers. Apply heavy sand top dressing to the area to top-up the tine holes, improve drainage characteristics and degrade thatch further.

- Aim to procure a Verti-Drain unit for the Club to facilitate routine aeration of the problematic “wet” section of the course, whenever windows of opportunity present themselves. It is suggested that a minimum of two annual operations (March and Oct/Nov) are essential to improve drainage performance and promote strong and healthy grass cover at the surface.
